A-1 Inspection Services
1266 S. 940 W. St.
Provo, UT 84601
(801) 377-0901
(800) 665-0901

Home Inspection Report

231 West Bubbling Brook Lane
Draper, UT 84020

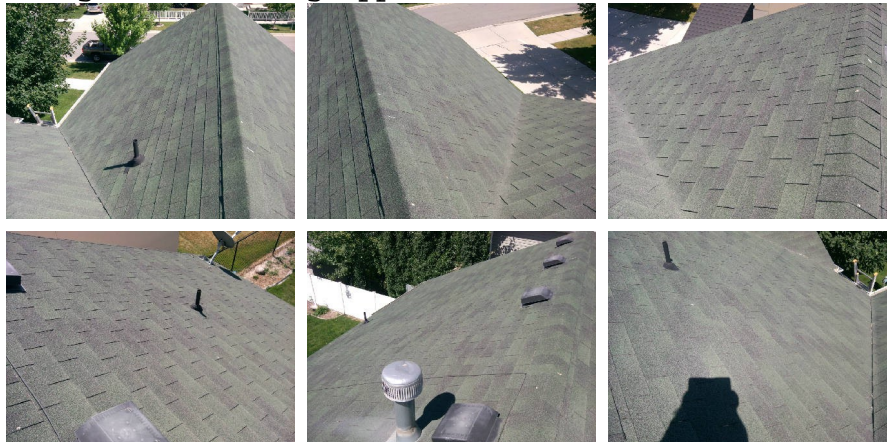
2. ☒ ☐ ☐ ☐ ☐ Material: Asphalt shingle The exposed asphalt roof covering shows satisfactory conditions at random. No missing/torn shingles observed. Shingle feathering appears minimal and normal.

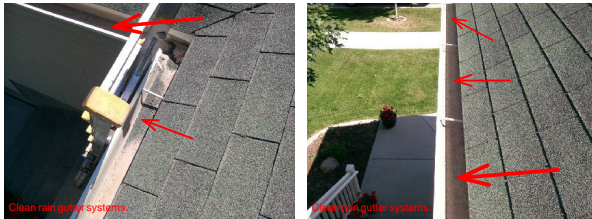
8. ☒ ☐ ☐ ☒ ☐ Gutters: Aluminum Clean at random as needed. Extend in rear as needed.

10. ☒ ☐ ☐ ☒ ☐ Leader/Extension: Suggest installing. Suggest installing downspout extensions as needed as to control roof drainage and control/divert perimeter drainage.

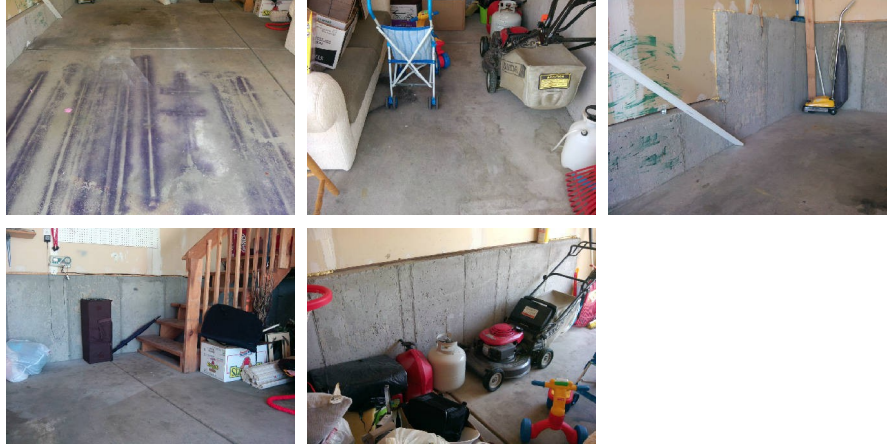
4. ☒ ☐ ☐ ☐ ☐ Floor/Foundation: Poured concrete, Poured slab The garage concrete flatwork systems show satisfactory and stable conditions at random. The garage concrete wall systems show satisfactory and stable conditions at random.

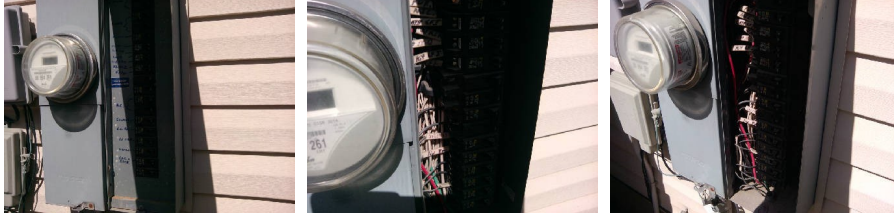
Exterior, side of house. Electric Panel

12. ☒ ☐ ☐ ☐ ☐ Manufacturer: Square D Shows satisfactory conditions and appears adequate.

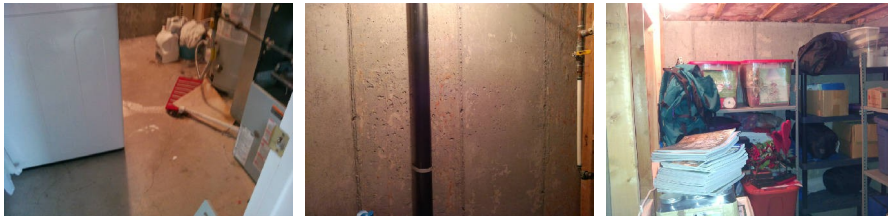
2. ☒ ☐ ☐ ☐ ☐ Foundation: Poured walls, Poured slab The exposed concrete foundation wall systems show satisfactory and stable conditions. The exposed concrete foundation flatwork systems show satisfactory and stable conditions at random. No signs of abnormal shifting and/or settling observed.

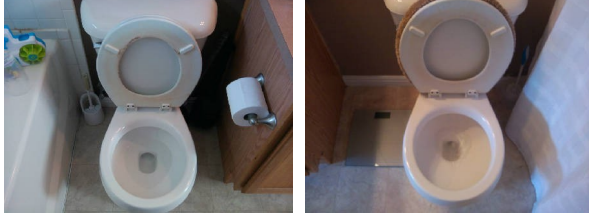
13. ☒ ☐ ☐ ☐ ☐ Toilets: 1 1/2 Gallon Tank The installed toilets appear fully functional. No leaks and/or seepage was observed.
